ONE JUDICIAL SQUARE BUILDING
CONCRETE REPAIR AT PARKING GARAGE

REPORT NO. S-2
DATE: NOVEMBER 19, 2012
SCALE: 1/8" = 1'-0"
PAGE NO. 1
DATE: NOVEMBER 19, 2012
PAGE NO. 1
LEVEL P1 - SOUTH
UNDERSIDE OF SLAB

STRUCTURAL ENGINEERS
ROBERT SILMAN ASSOCIATES

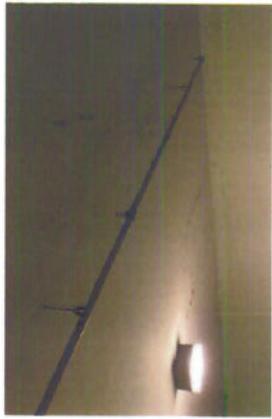
PHOTO 2 - TYPICAL CONCRETE DELAMINATION AREA AT UNDERSIDE OF P1 SLAB DECK.

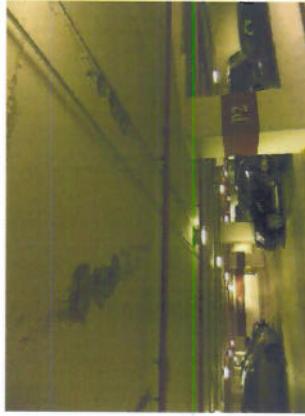
PHOTO 3 - TYPICAL CONCRETE DELAMINATION AREA AT UNDERSIDE OF P1 SLAB DECK.
